Refinishing A Stevens .410 Double Shotgun

by Dominick Pisano

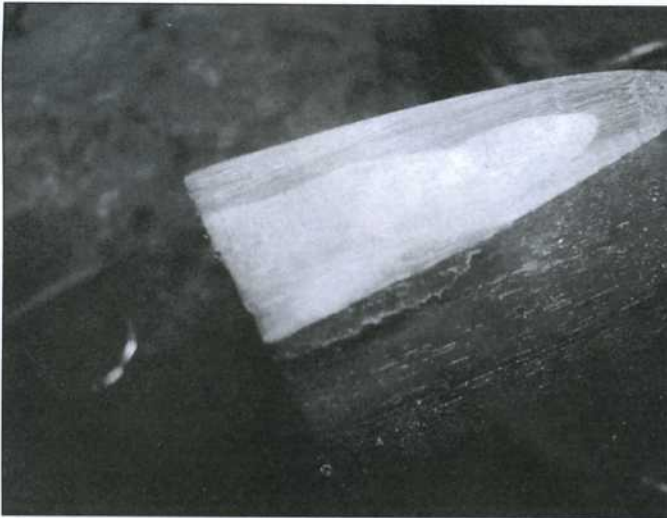
***Above left:** Chipped toe is smoothed out and squared up prior to a glue up of the patch. **Above right:** Patch glued in place and clamped up.*

Next I examined the chipped-out toe and proceeded to remove excess wood from the chip to make it smooth and flat. After I had removed enough wood I found a scrap piece of walnut of approximately the same color and cut off a piece approximately 1/2" x 1-1/8" x 3-1/2". This was smoothed up to guarantee a tight fit and provide a joint that would almost be invisible. Then it was a simple matter to mix up a small quantity of Brownells Acraglas Gel, add some brown stain and glue up the two parts. A small clamp applied enough pressure to insure a tight joint. Next came the trimming of the parch to size using various rasps and files. Along the way I also replaced the dowel from the previous repair.

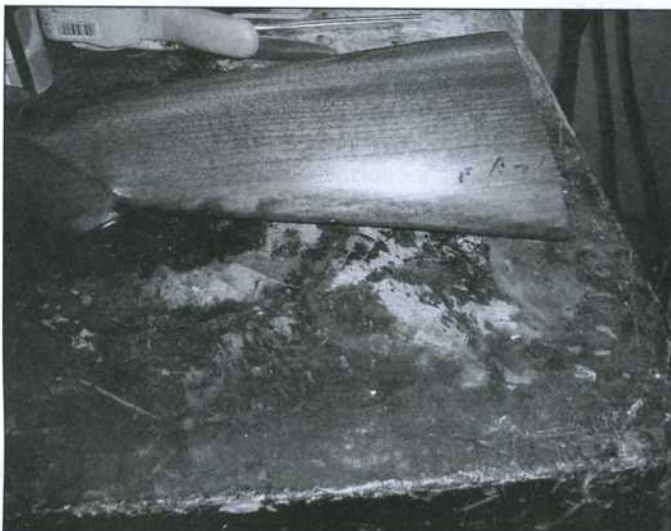
***Below left:** The toe repair is almost invisible. **Below right:** Another view of horizontal crack glue up and the clamps.*

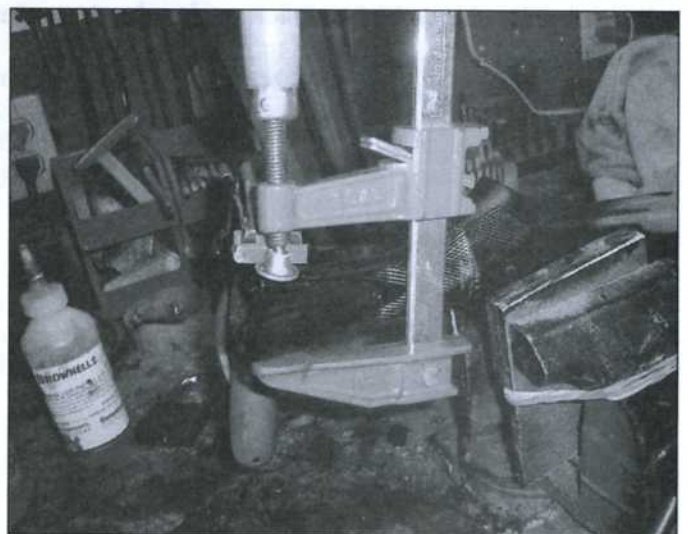
Unfortunately, one of the cracks opened up again, probably due to excessively oily wood. I applied two treatments of Whiting and pulled a pile of oil out of the stock. With that accomplished, I once again glued up the horizontal crack on the lower left part of the wrist using clear epoxy. Unfortunately, the crack opened up again after I removed the stock from the receiver. Apparently, the Whiting had failed to get far enough into

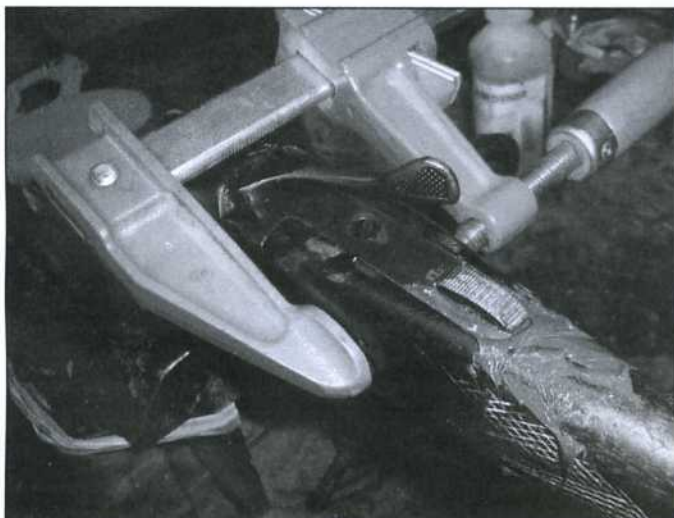
Now it was time to repair the major vertical crack which began at the juncture of the receiver and extended well back into the wrist. I cleaned the interior of the inletting to allow the epoxy to adhere properly and then opened up the area where the frame's rear tang meets the wood, hollowing it out below the surface of the wood to allow a build up of Acraglas Gel epoxy to fill the void created, thereby strengthening the area. This is where most of the recoil is absorbed when the gun is fired.

Above left: Major vertical crack glued up and clamped. Note the generous use of epoxy. *Above right:* The recess mortices in the rear of the frame and the tenons in the stock epoxied together. Metal tape is placed on the frame to protect it during final sanding.

Because the crack was severe, I determined I would make the repair in two steps. The first step consisted of mixing up a batch of clear epoxy and applying it to the crack after opening it up bit to accept the epoxy. This would ensure a tight bond for the application of the Acraglas Gel in step two. I set the project aside for twenty four hours to allow the epoxy to cure.

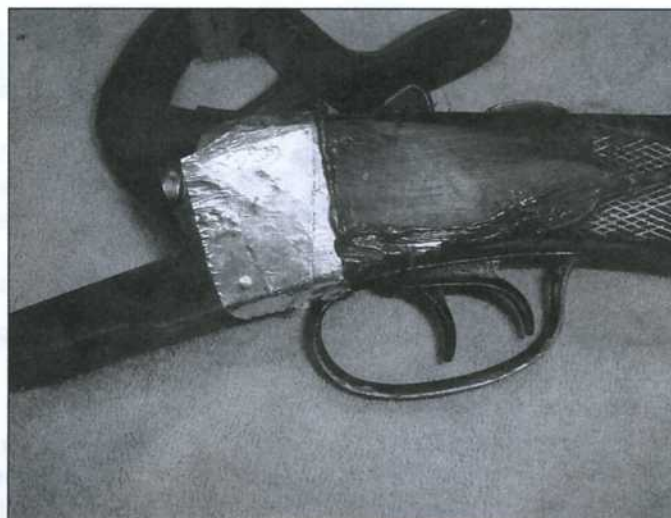
The final step was to repair the area where the rear of the receiver and the wrist come together. This area was badly battered and the tongues on the stock were completely missing on one side and partially missing on the other. They are designed to fit into recesses in the rear

of the frame to keep the sides of the stock from spreading apart upon recoil. This was accomplished by applying a small amount of epoxy gel to the front of the butt stock and applying more of the gel to the recesses on the frame. I was careful not to use too much epoxy as this would likely get into places where it didn't belong. After this was completed I clamped up the sides to get a proper fit. The following day I removed the clamps, smoothed away the excess epoxy and began the pro-

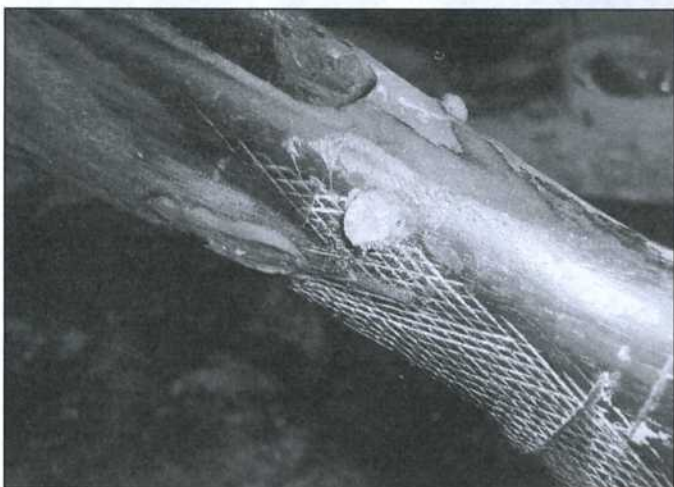
Below left: Dowels were installed to be certain the repair would hold up under use. The dowels were later smoothed flush. *Below right:* Completed repairs. Note that the dowels can not be seen.

The customer told me that he was not interested in an ultra refinish, requesting me to, "just make it presentable and shootable". Thus, I repaired this crack using a quarter-inch walnut dowel. While I was at it I reinforced the large vertical crack which was previously repaired and appeared to be holding up with another dowel of the same size. Both dowels would ultimately be difficult to see once the stock was refinished and the checkering recut.
